Asbestos Survey Report

13400 West Outer Drive
Detroit, MI 48239

Detroit Diesel Corporation
13400 West Outer Drive
Detroit, MI 48239
313-592-7086

Date of Inspection: 08/08/2023

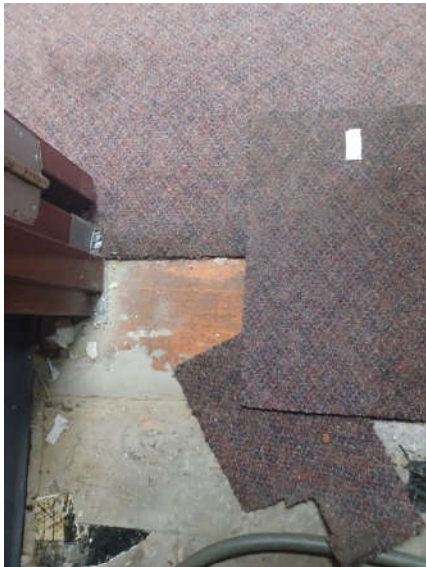
Positive 9x9 Floor Tile, Grey & Mastic, Black

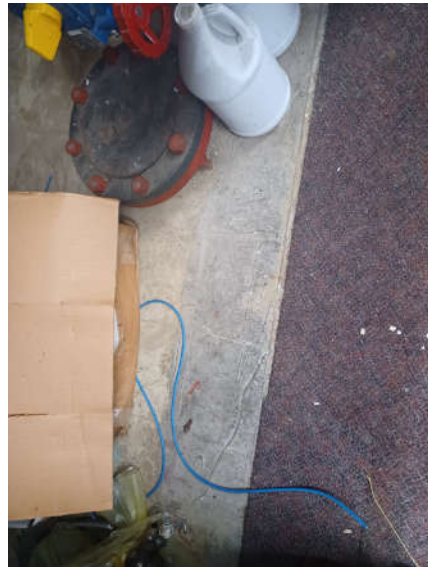
Positive 9x9 Floor Tile, Beige & Mastic, Black
